MICROCHIP PIC12(L)F1822/PIC16(L)F1823

PIC12(L)F1822/PIC16(L)F1823 Family Silicon Errata and Data Sheet Clarification

The PIC12(L)F1822/PIC16(L)F1823 family devices that you have received conform functionally to the current Device Data Sheet (DS40001413E), except for the anomalies described in this document.

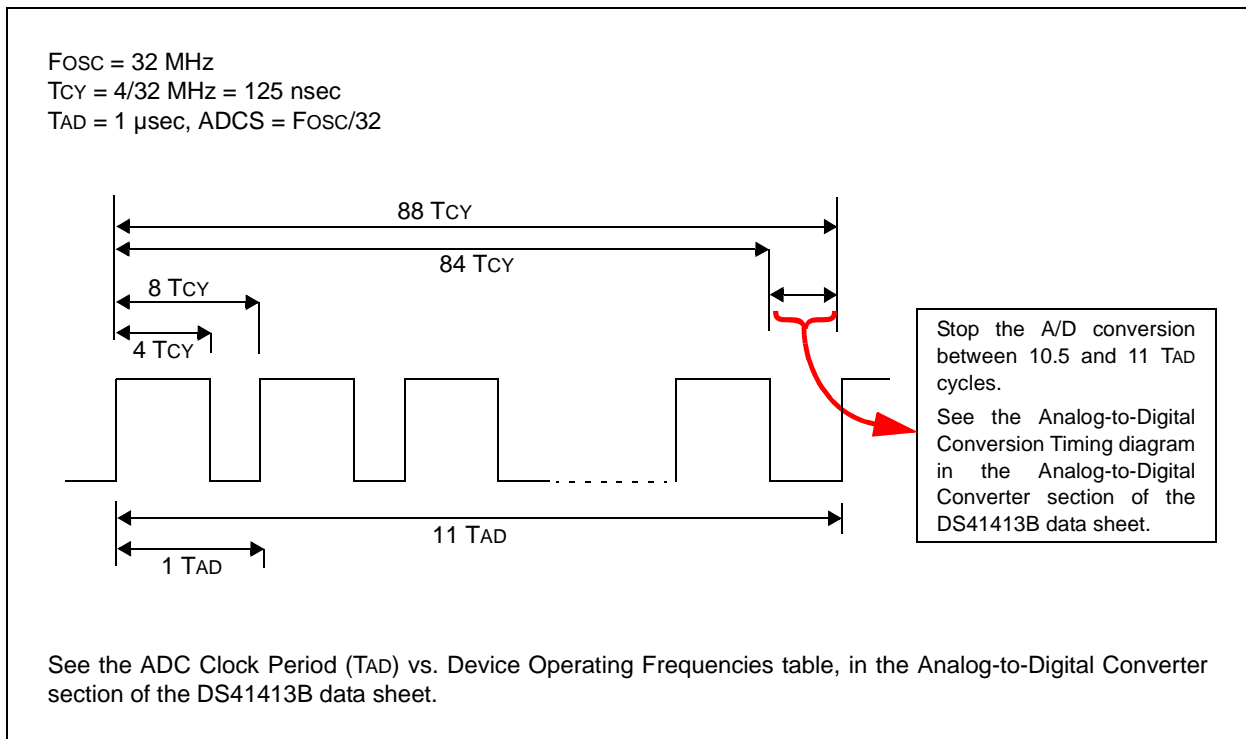
FIGURE 1: INSTRUCTION CYCLE DELAY CALCULATION EXAMPLE

Under certain device operating conditions, the ADC conversion may not complete properly. When this occurs, the ADC Interrupt Flag (ADIF) does not get set, the $\overline{\text{GO/DONE}}$ bit does not get cleared and the conversion result does not get loaded into the ADRESH and ADRESL result registers.

In [Figure 1](#), 88 instruction cycles (TCY) will be required to complete the full conversion. Each TAD cycle consists of 8 TCY periods. A fixed delay is provided to stop the A/D conversion after 86 instruction cycles and terminate the conversion at the correct time as shown in the figure above.

Note: The exact delay time will depend on the choice of FOSC and the TAD divisor (ADCS) selection. The TCY counts shown in the timing diagram above apply to this example only. Refer to [Table 3](#) for the required delay counts for other configurations.

Method 2: Provide a fixed delay in software to stop the A-to-D conversion manually, after all 10 bits are converted, but before the conversion would complete automatically. The conversion is stopped by clearing the $\overline{\text{GO/DONE}}$ bit in software. The $\overline{\text{GO/DONE}}$ bit must be cleared during the last $\frac{1}{2}$ TAD cycle, before the conversion would have completed automatically. Refer to [Figure 1](#) for details.

```
BSF    ADCON0, GO/DONE; Start ADC conversion
        ; Provide 86
        ; instruction cycle
        ; delay here
BCF    ADCON0, GO/DONE; Terminate the
        ; conversion manually
MOVF   ADRESH, W      ; Read conversion
        ; result
```
