## PIC16F818/819 Rev. A4 Silicon Errata Sheet

The PIC16F818/819 Rev. A4 parts you have received conform functionally to the Device Data Sheet (DS39598E), except for the anomalies described below.

The following silicon errata apply only to PIC16F818/819 devices with these Device/Revision IDs:

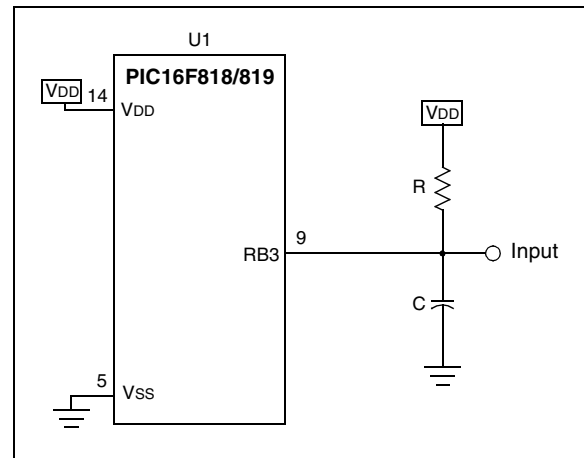
**FIGURE 1:**

If the following conditions are present on RB3, a device Reset may occur.

1. RC combination on RB3 (see Figure 1).
2. RB3 configured as an input via TRISB.
3. RB3 is driven low.

1. A Reset condition may not occur if a specific resistor/capacitor combination is used. It has been observed that a 10 kΩ resistor and a capacitor value of 4.7 nF or less does not cause a device Reset. If the user must have a RC configuration using RB3, then experimenting with different RC values is recommended.
2. Do not configure RB3 with the above conditions shown in Figure 1. Instead, use another I/O pin for the RC configuration.
